REBUTTAL STATEMENT

King William IV, Speen

Ref 25/05240/CLE

Save the King William IV Group

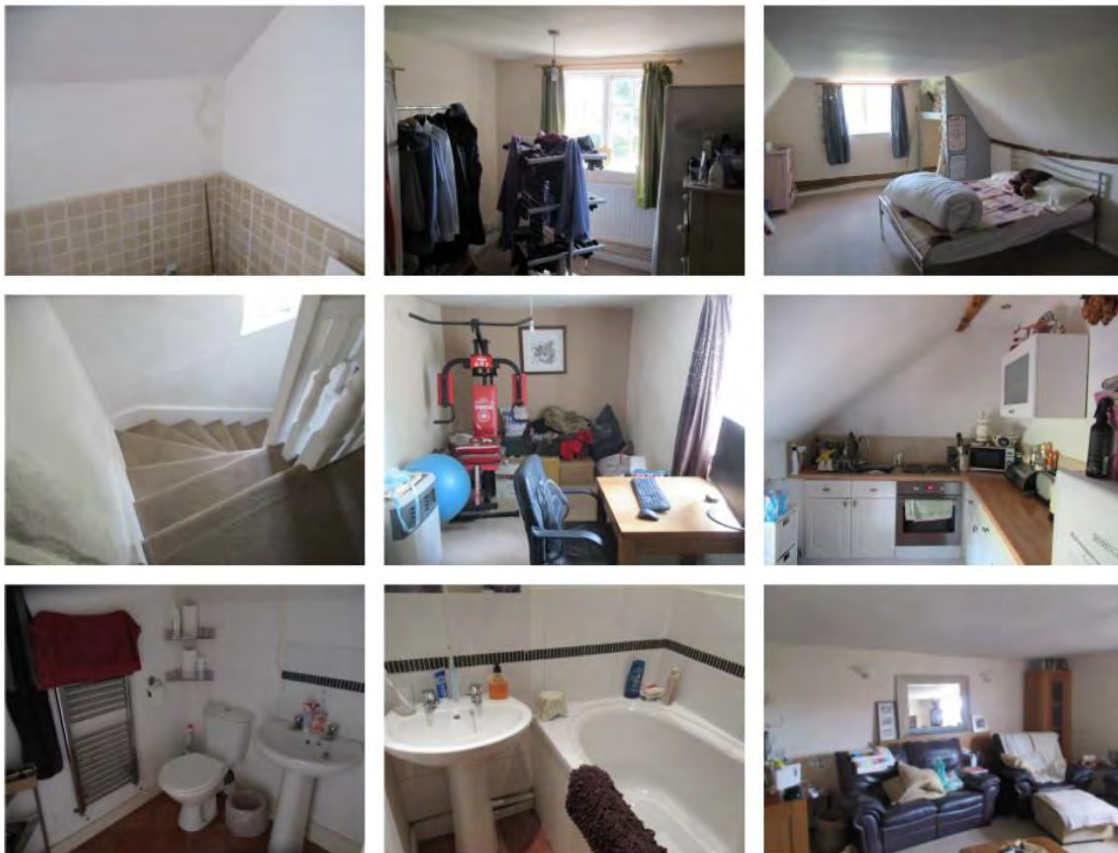
Private accommodation

Paragraph 10 claims that the transition to using the ground floor was completed by 31st March 2020. It states that “*the first floor living room was repurposed as a bedroom*”. However, page 5 of the MJD Hughes Report states clearly that the first-floor accommodation, which he viewed in June 2021, included the living room. Again, the first floor living room use is apparent in the photographs on Page 43 of the report. (see bottom right photograph).

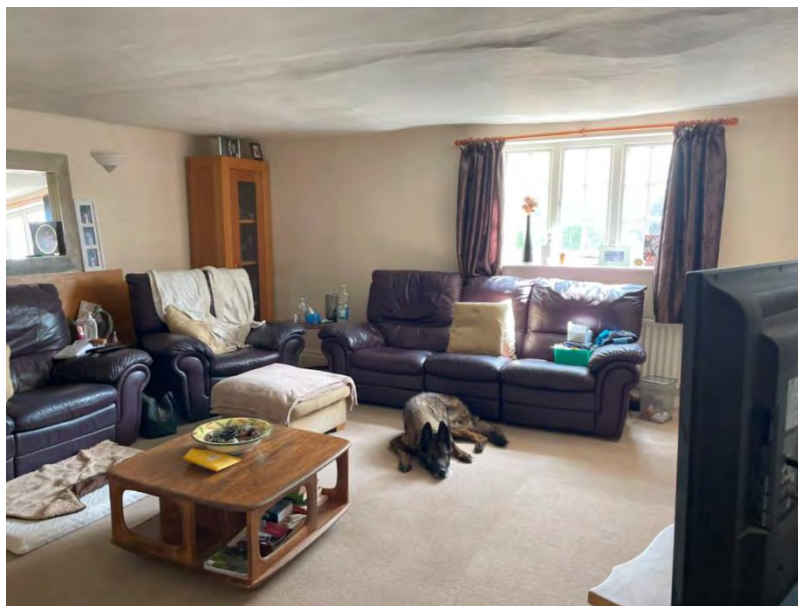
Figure 22 (p.26) Heritage Impact Report November 2023

However, figure 22 on page 26 of the 2023 Heritage Impact Report by HCUK Ltd for the owner as part of the planning application for change of use (23/07884/FUL) shows the first floor sitting room still fully furnished and the German Shepherd lying on the floor over three years later, in November 2023.

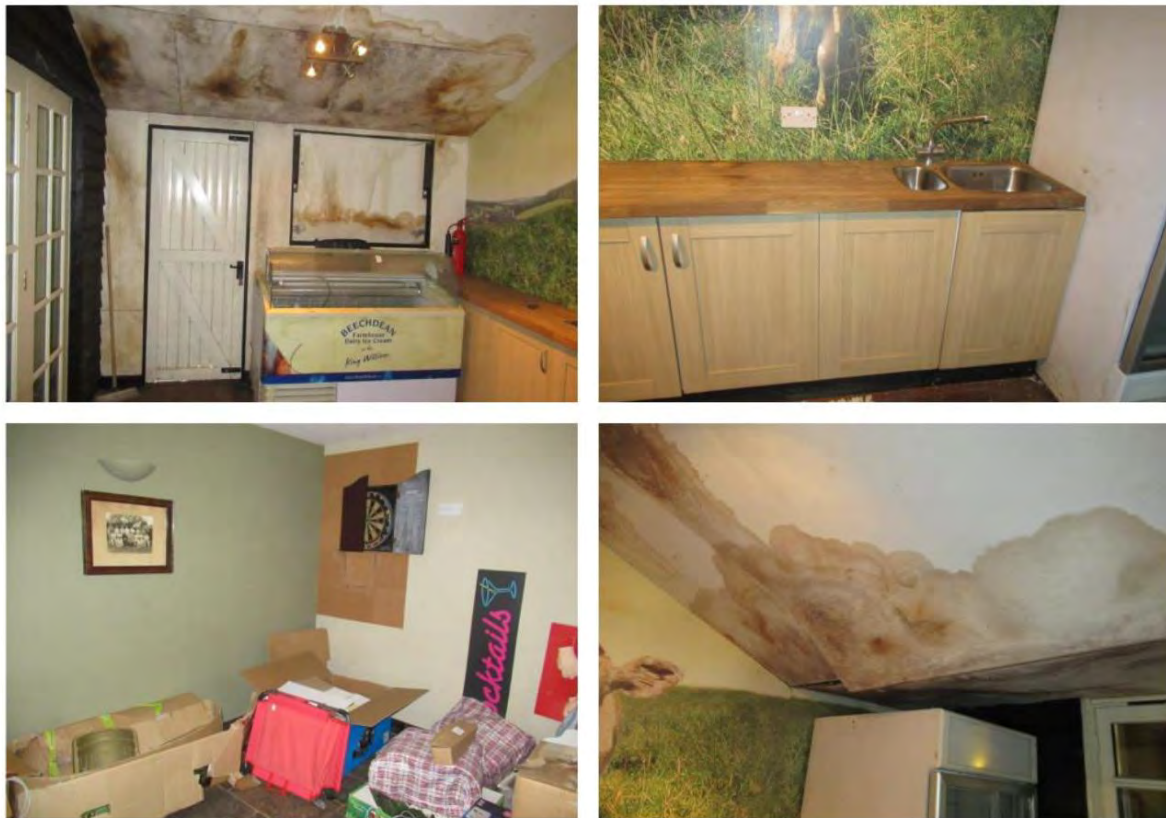
Ice Cream Parlour and family room

Again, these claims are unsupported by the evidence. Photographs with the statement show a pool table in the bar area at this time. Photographs in the MJD Hughes Report on page 40 show the parlour area suffering severe damp with no evidence of redecoration.

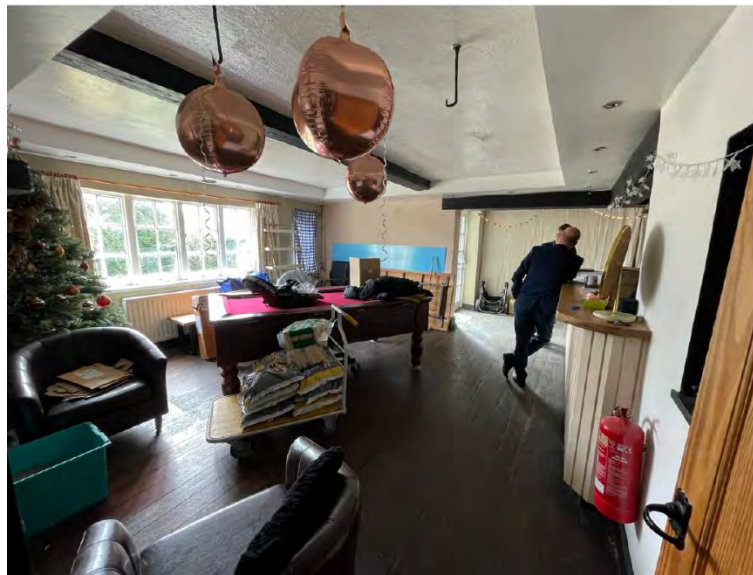
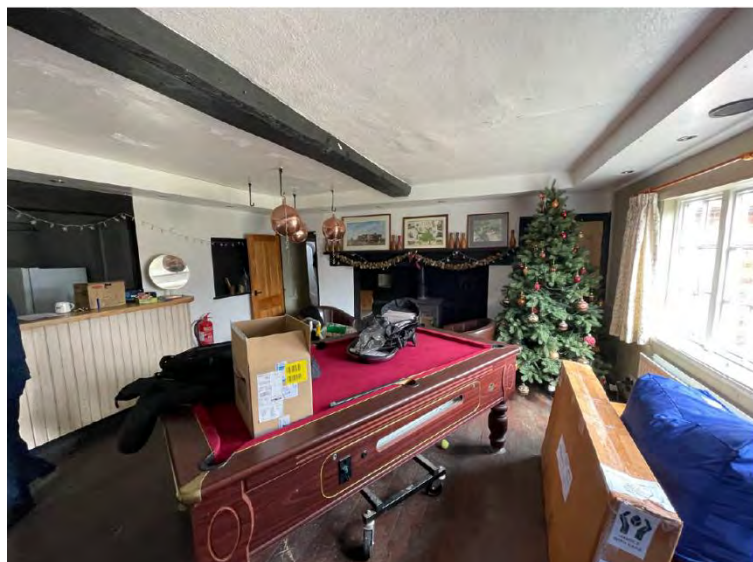
**P. 11 Design & Access Statement 15.11.23
Photographs of the Bar Area taken 07.10.2023**

Christmas tree in this area. The photographs also provide no support for the contention that a hot tub was in situ at the far end of the room. Further, the Design and Access Statement was prepared by George Courtauld in **October 2023** as part of the original Change of Use Application submitted to the council on 17th November 2023. The presence of a fully decorated Christmas tree at this time of year would support the view that this room was merely used for random storage and not as residential accommodation. Moreover, the photographs of the bar, pool table, and original pub sofas illustrate that this was still essentially configured for use as a public house, albeit dormant.

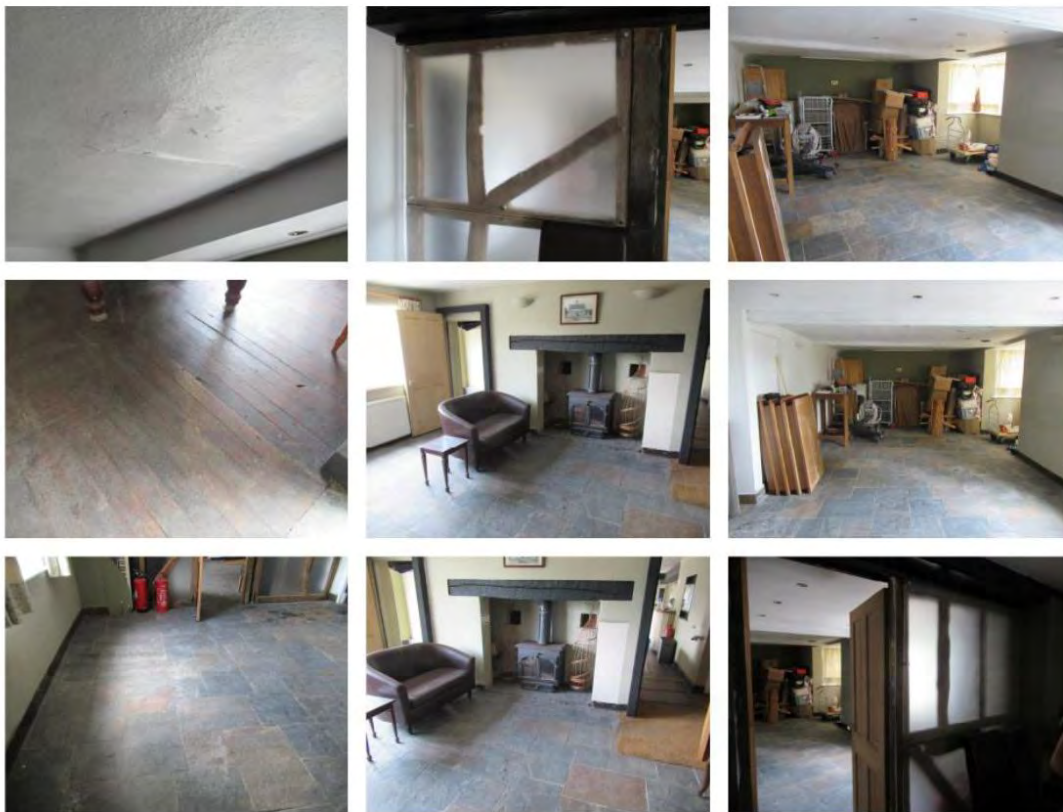
In particular, this report shows the former restaurant area as part of the Trade Area with a few chattels being stored with no evidence of residential use. (See the photograph in the top right corner of page 37 reproduced below).

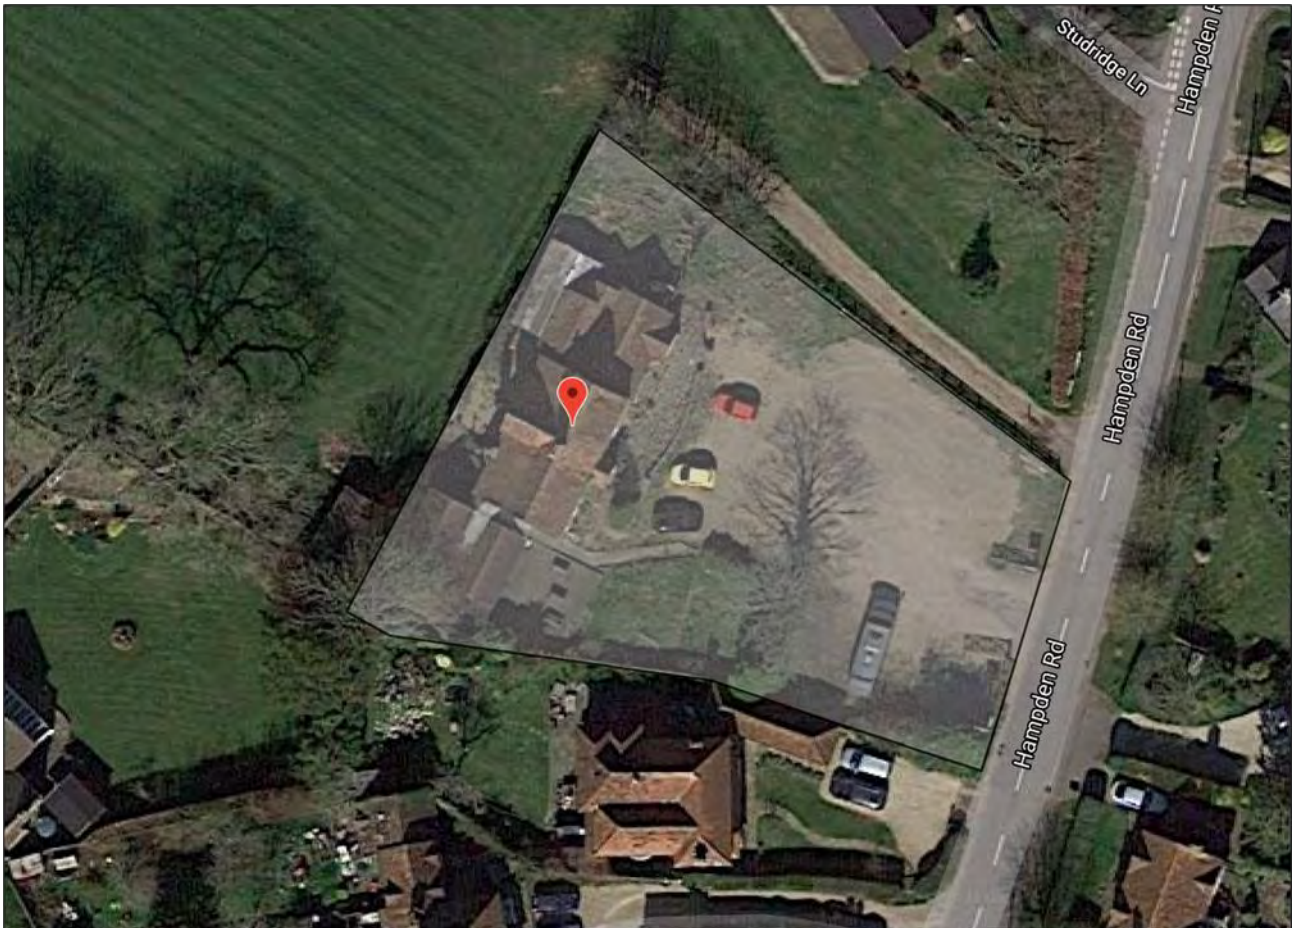
Building and plot measurements:

Area 1654 meters², 17798 feet² 0.41 acres
 Perimeter 165 meters , 542 feet

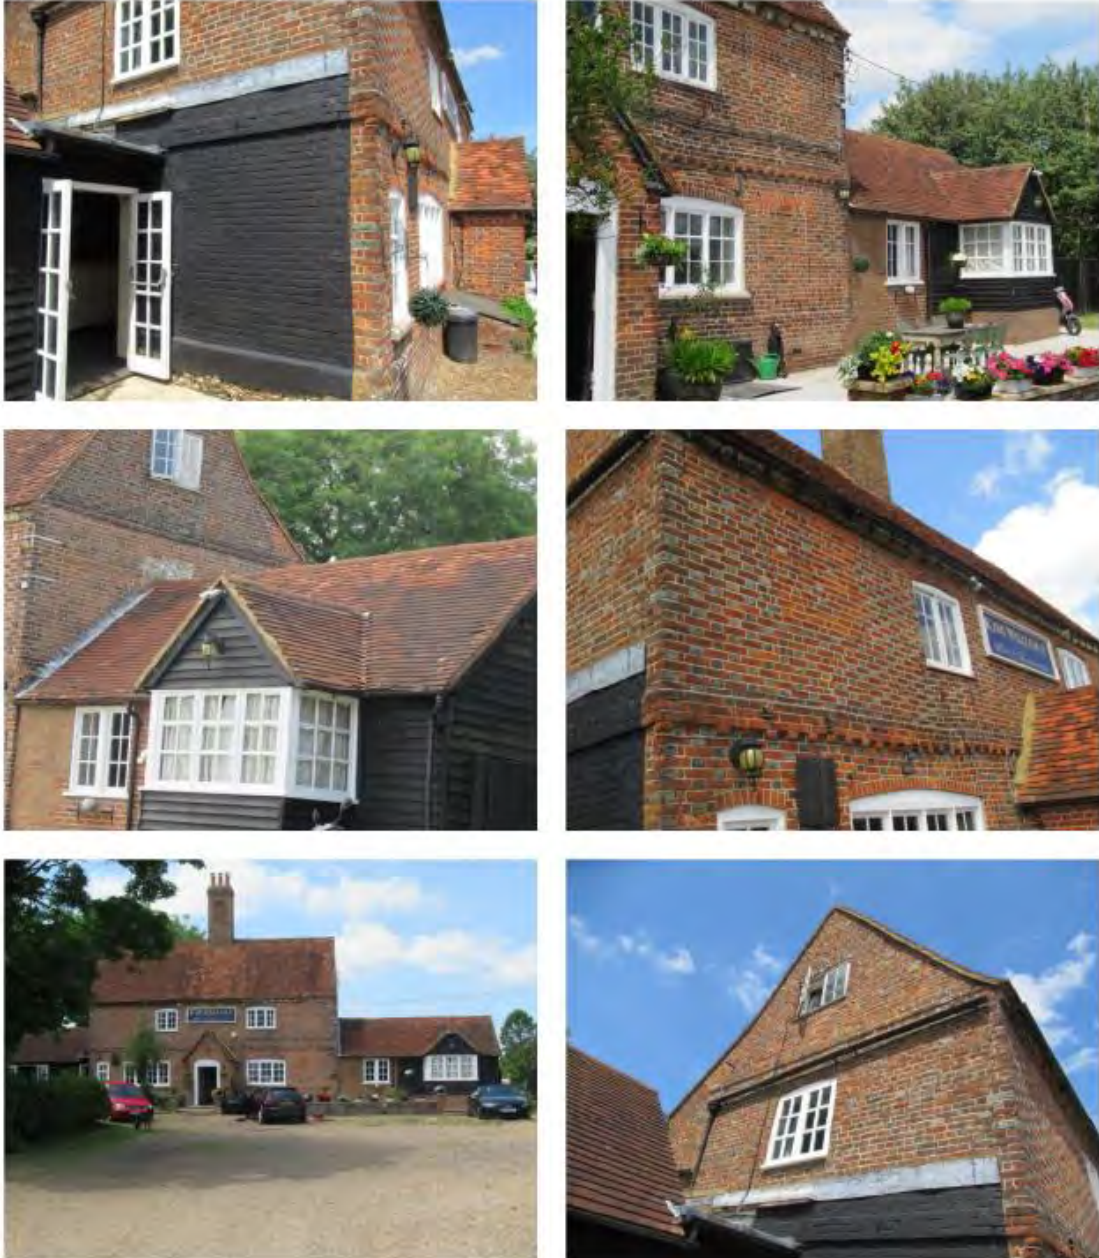
Front Elevations

Various masonry is showing signs of spalling. These sections will need to be repaired and replaced. Windows throughout the property vary greatly in their condition. In the short term many can be repaired by cutting and splicing wood to the frames before preparing and painting. Long term all windows to the property will need replacing.

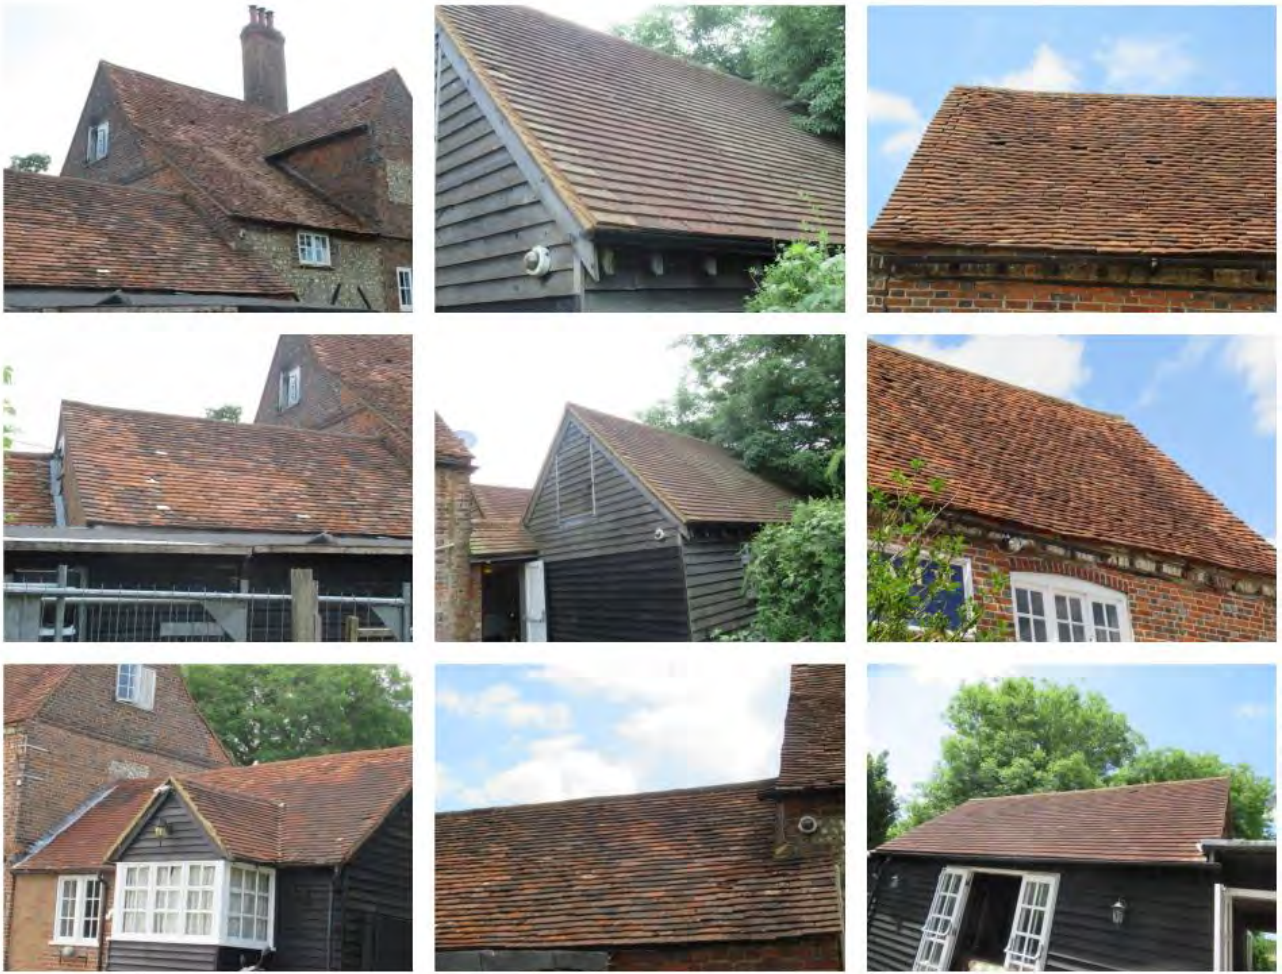
Pitched roof sections

The exterior of the property requires immediate attention to ensure various features do not deteriorate further. The condition of the tiles to all sections of pitched roof vary significantly with some areas in good condition and others requiring immediate attention. The triangulation to the various sections of pitched roof shows signs of spread and also unevenness. This is to be expected of a roof that has been in place for a long period of time. Localised repair will be difficult to achieve due to the delicacy of the tile covering. Whilst we could not achieve a thorough investigation of the timbers, due to the age and condition of the roof we suspect that much of this may need to be repaired or renewed to meet current building regulations. Each pitched roof section will need to be replaced within a period of about 5 years. The property can operate and be occupied as the roof currently stands but the cost of these works will need to be factored into an ongoing maintenance schedule.

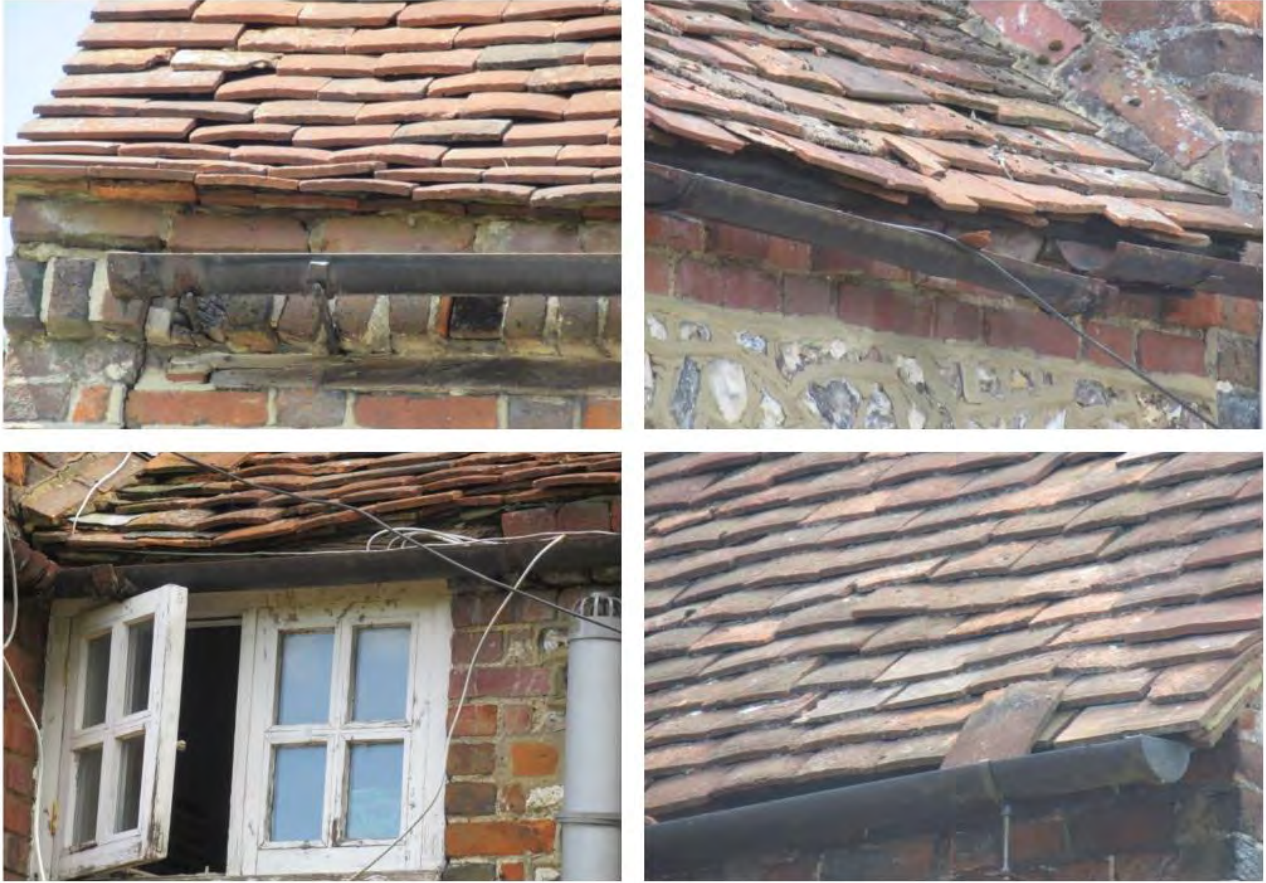
Rainwater goods - detail

Rainwater goods to the exterior of the property are showing the signs of their age with many of the brackets and joints needing renewal. Repairs to the rainwater goods will help avoid replacement and renewal.

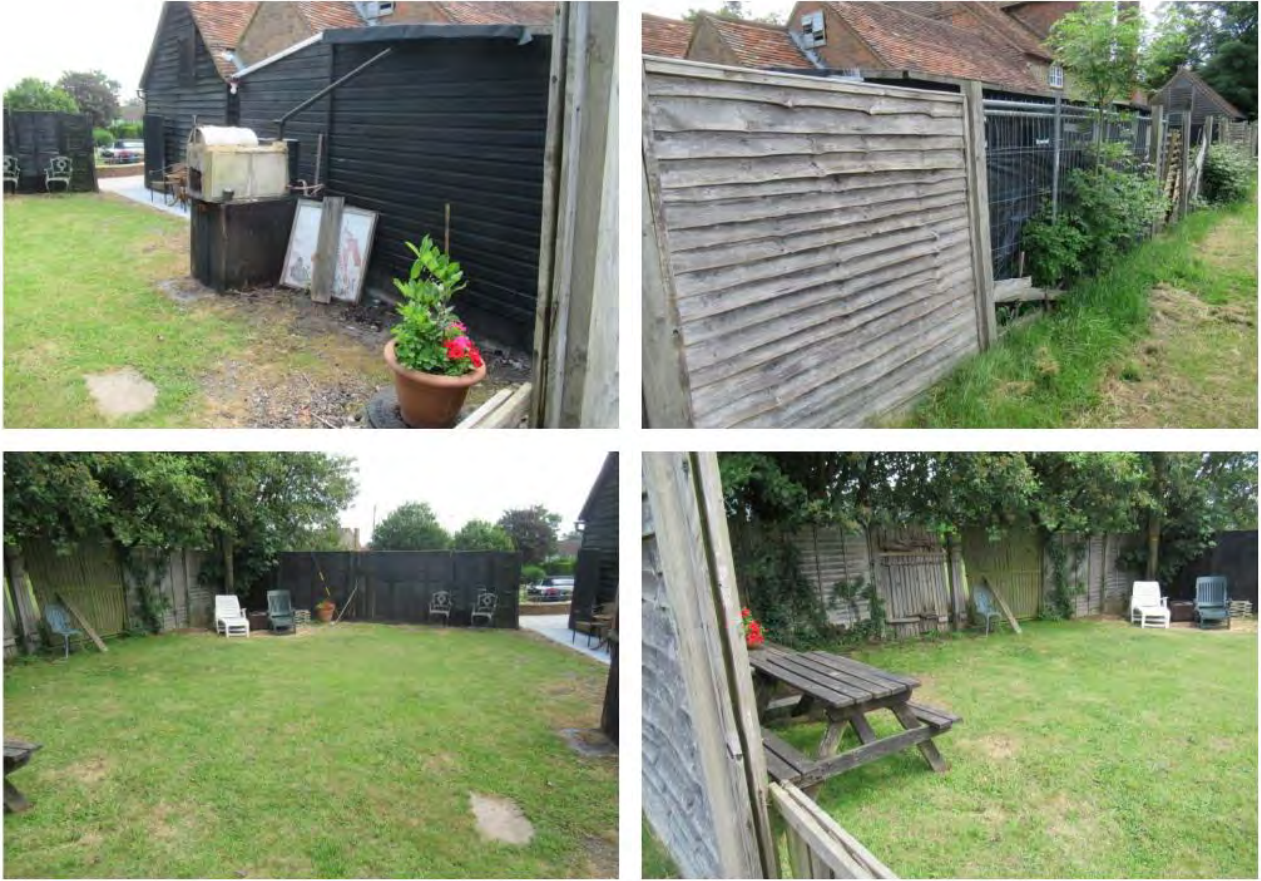
Private garden, side and rear fencing

The car park, rear yard and private garden are in reasonable condition. The fencing running from the side of the property through to the rear, and enclosing the rear yard is in a poor condition with many of the fence panels missing or broken. This fence should be renewed. Plant growth and vegetation to the perimeter and roof is evident. This will damage the property if permitted to continue and so should be removed.

Estimated cost of fence replacement: £2,000 to £3,000

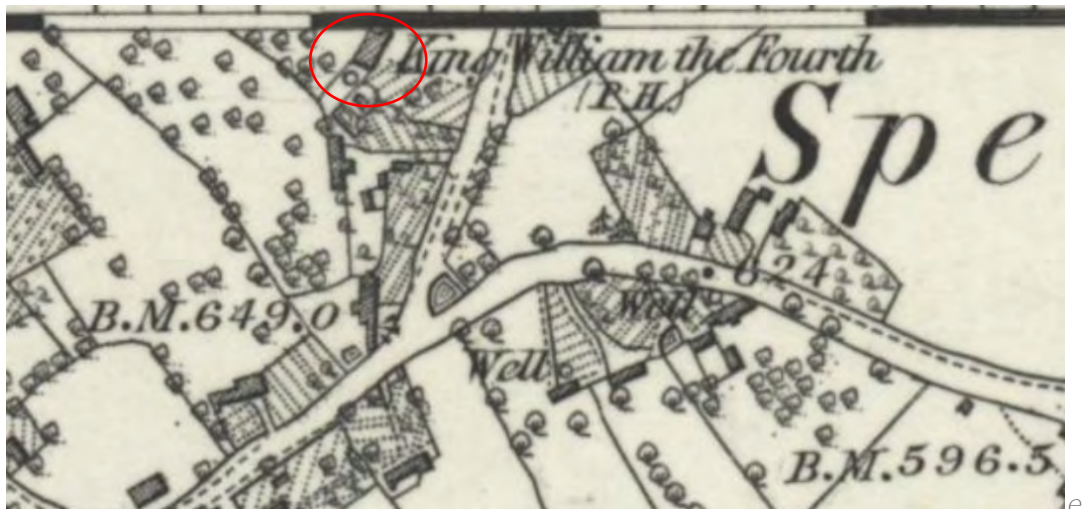
Figure 2: 1885 OS Map (surveyed 1874-1880). Reproduced with the permission of National Library of Scotland.

- 3.2 While having its origins in the 17th century, King William IV Public House is recorded on the 1885 Ordnance Survey map (OS hereafter; Figure 2)¹¹. Though not particularly clear this map shows the building with a rectangular form with a possible small extension to the north elevation (likely to be a small barn). It faces the road - though is set back - with no access road visible (this may be due to the name of the Public House obscuring it). The King William IV is shown as having an irregular plot with what appears to be a formal garden with trees in front of the Public House on the south side, and a pond to the south-east. At this time the fields behind were most probably associated with the pub - or at least the farm that the pub was once a part of - and are recorded as being a cherry tree orchard¹². The map also just shows the south end of Rose Cottage, with a garden area in front.

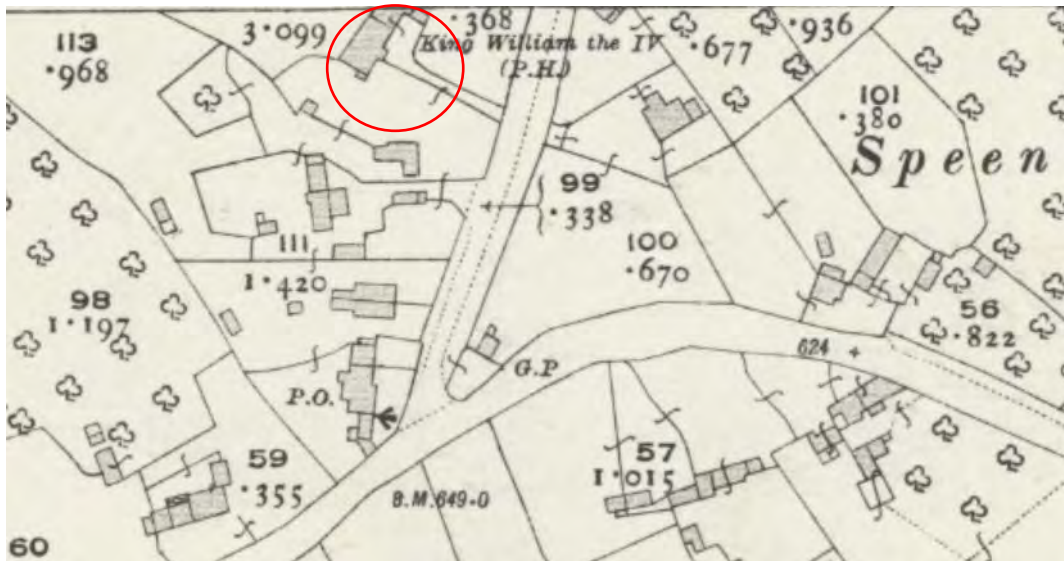
Figure 4: 1921 OS map (surveyed 1919-1921). Reproduced with the permission of National Library of Scotland.

- 3.4 The 1921 OS map (Figure 4) shows a comparable situation to that of 1898 but with some key changes. Firstly, the porch on the front elevation is clearly identifiable; secondly the side extension (barn) to the north now appears to project beyond the front elevation; and thirdly the pond is no longer shown. This OS maps also shows the continuing development of the village with the construction of several houses to the south and throughout the village.

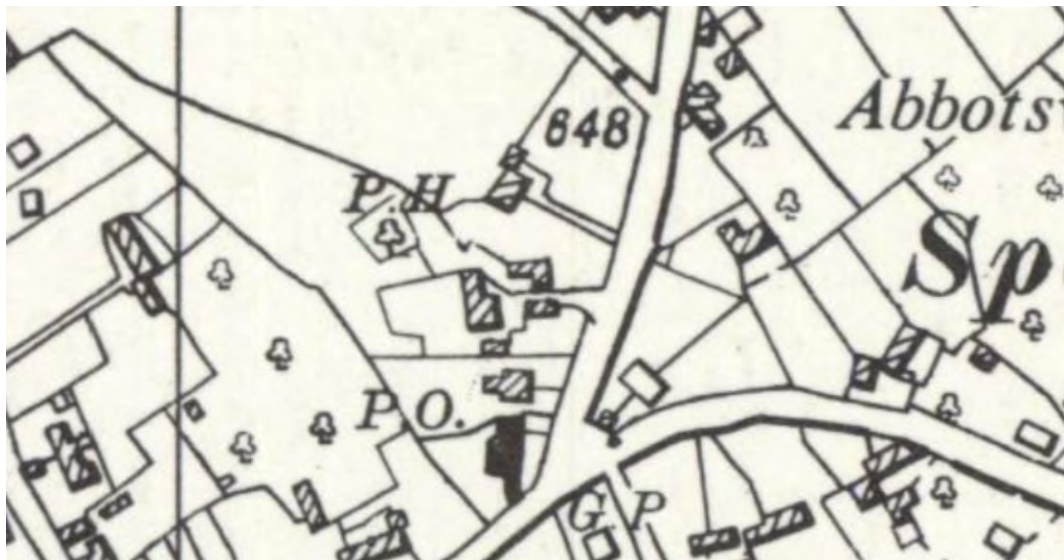
Figure 5: 1960 OS map (surveyed 1939-1959). Reproduced with the permission of National Library of Scotland.

The 1960 OS map is less detailed though the situation is comparable to 1921 aside from the side (north) extension being considerably smaller and no longer having a front projection. The small outbuilding is not shown and so this suggests it had been demolished.

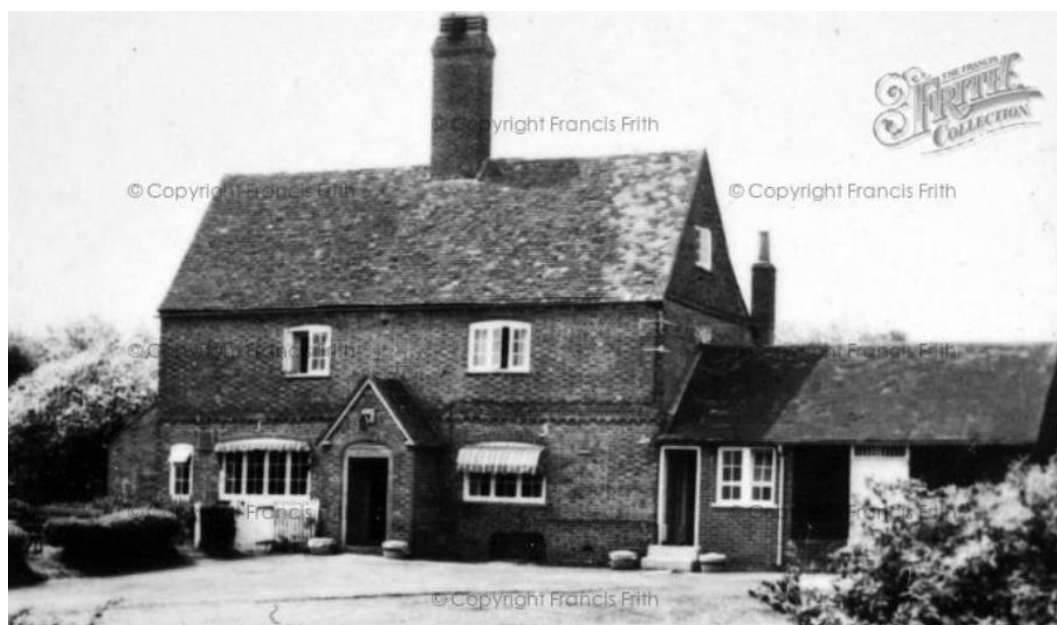
Figure 6: Photograph of The King William IV Public House.

Around a similar period to the 1960 OS map a photograph was taken of the Public House, prior to 1963 (Figure 6). The pub has not yet got any signage (this was

added in 1963; WR/1519/63) and appears more as a farmhouse, rather than the Public House it was with only the window awnings suggesting such. There is a one storey extension attached to the side elevation (north) which appears to be constructed of red brick, with weather boarding at its north end (a small barn or storage area), and a clay tile roof. The small lean-to extension on the south side is also visible. **A slightly later photo (most probably from the late 1960's; Figure 7)** shows the pub with its signage and table and chairs in front on the south side of the front garden.

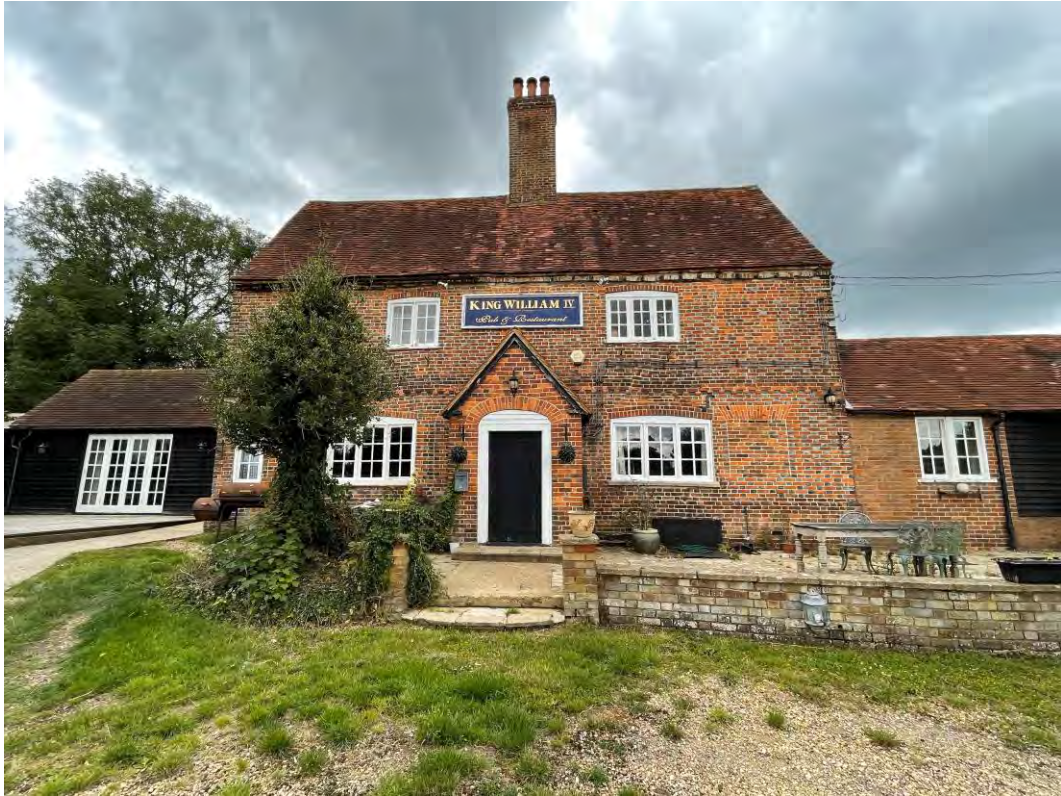
Figure 8: The King William IV Public House 2023.

3.9 The existing Public House is a two-storey red brick building (flint parts at the rear) with a timber roof structure. It has a clay tiled roof with central chimney stack – the windows to the front elevation are as described within the list description above. At the entrance is a porch. On the north side there are several single storey extensions, and on the south side a single storey extension with what used to be an ice cream parlour attached (in 2009; 09/05721/FUL). Internally, at the ground floor level the main house consists of five rooms (though part of the wall has been knocked through between the existing bar and the front room) and a hallway where the staircase is located. The north extensions consist of two large rooms and a large storage area at the rear, and the south extension three large rooms and the WCs. The first floor consists of seven rooms and a hall, with one of the original front rooms (south) now subdivided. At the second floor there are two rooms, a hall and a storage area. The cellar was not accessed. The rooms have been numbered to assist when describing them (see appendix 3).

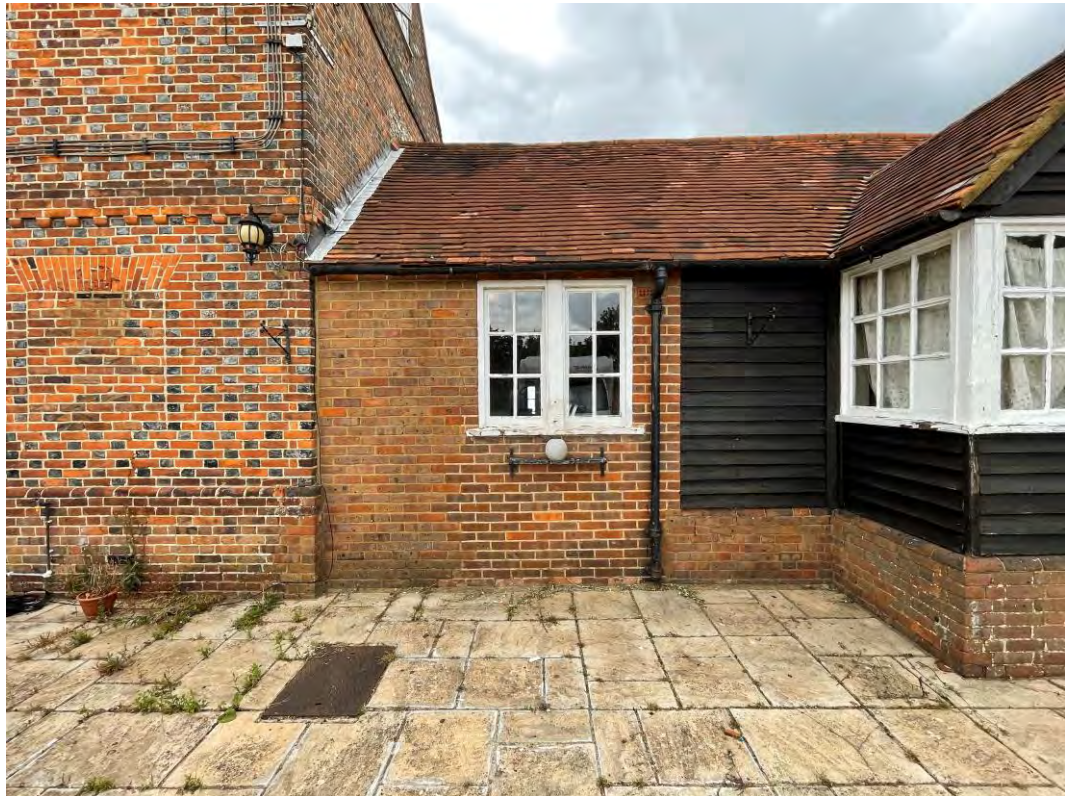
- 3.13 The north extensions consist of several elements, with a 1960s shed/barn at the rear, and what was possibly formerly a barn at the front. As stated above the cartographic evidence suggests that there has been a built element in this location since at least the late 19th century. However, these elements have largely been rebuilt (see modern brickwork Figures 12 and 13), including the addition of a bay window (W/5383/81). The structures whether later additions or highly altered historic structures are now essentially of modern construction.
- 3.14 The south extension was added in 2005 (05/05870/LBC) with the ice cream parlour added in 2009 (09/05753/LBC).

Figure 12: Front elevation of north extension. Brickwork has been rebuilt.

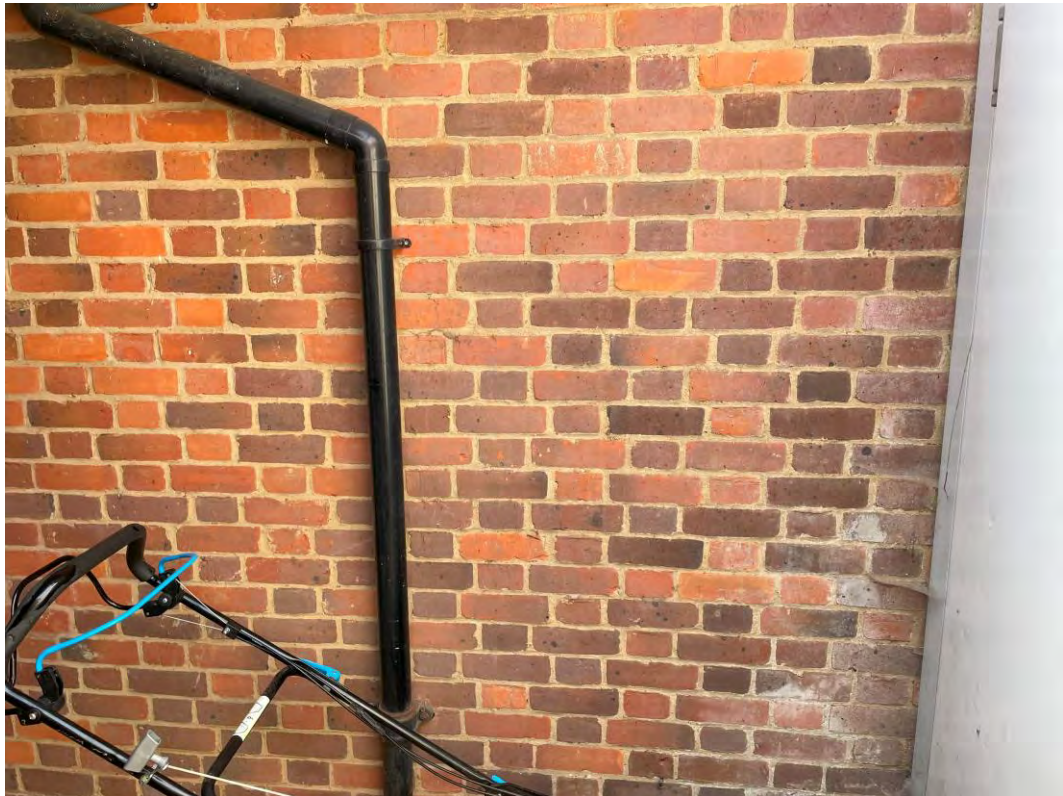
Figure 13: Rear of front section of north extension. Brickwork is modern.

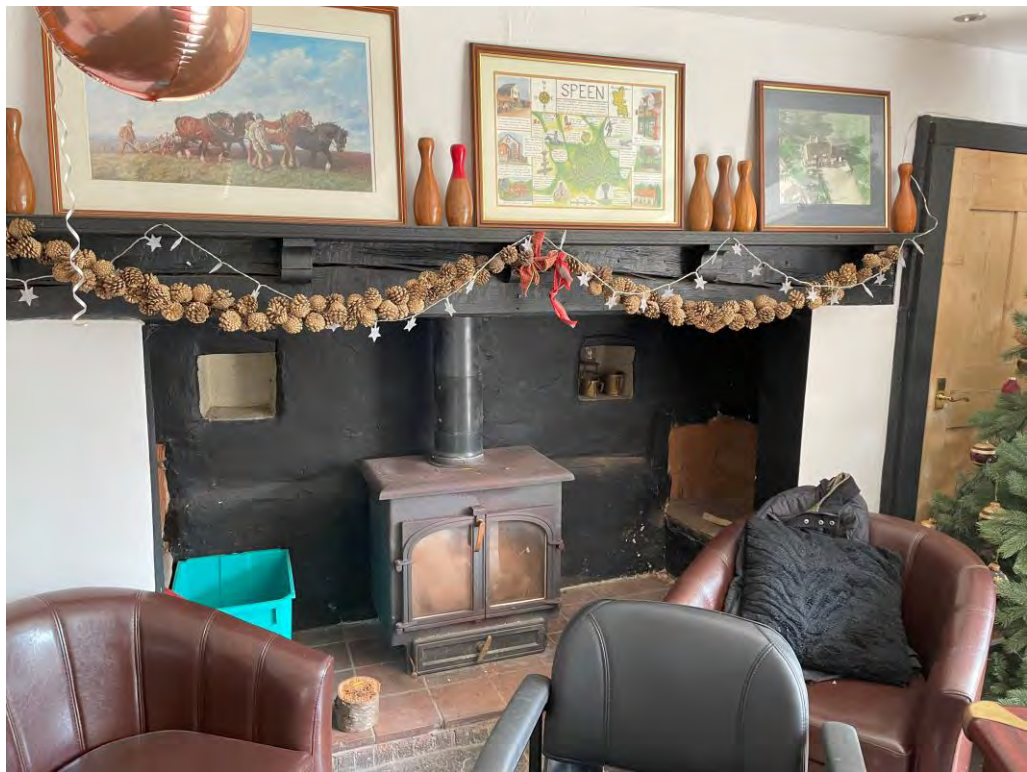
- 3.17 The ceiling includes a timber beam and modern recessed lights within a dropped ceiling. There are two doors, one in the north-east corner which leads through to room 2 and the other in the south-east corner which leads to the hallway and then the porch.

Figure 14: Inglenook Fireplace; Room 1

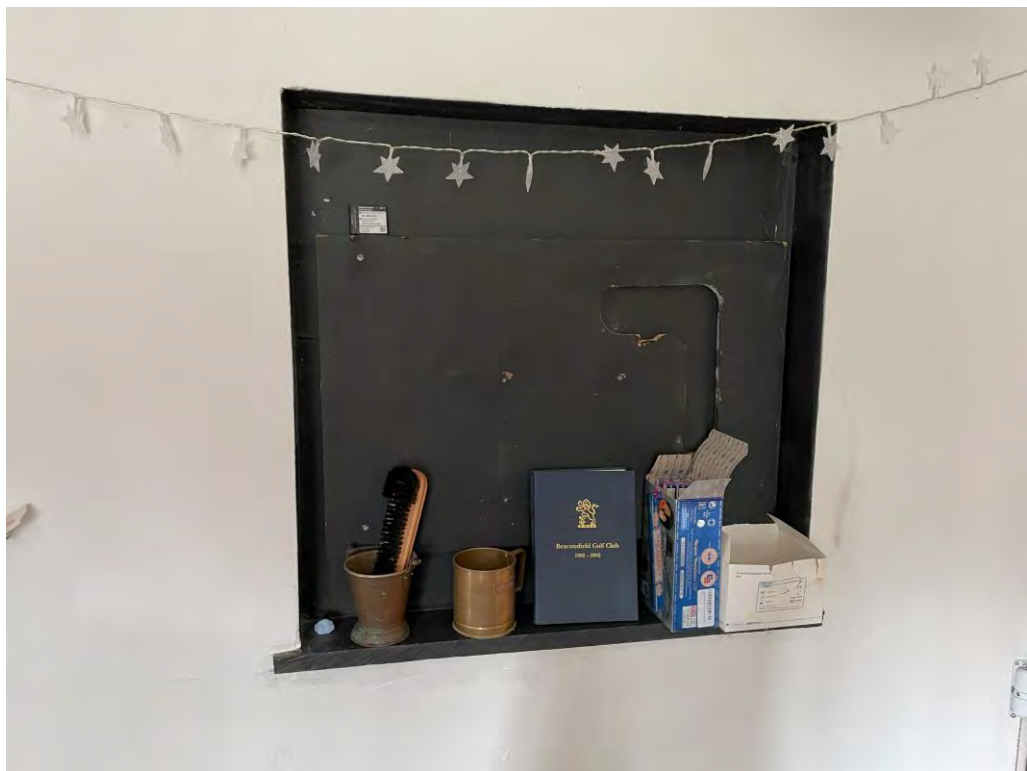
Figure 15: Serving hatch

- 3.16 Perhaps the most significant feature in the room is the inglenook fireplace. Whilst the wood burner is modern and the hearth highly altered, the shelves and benches are original, though the timber elements of the benches appear to have been replaced. Also, in the north-east corner of the room is a serving hatch.

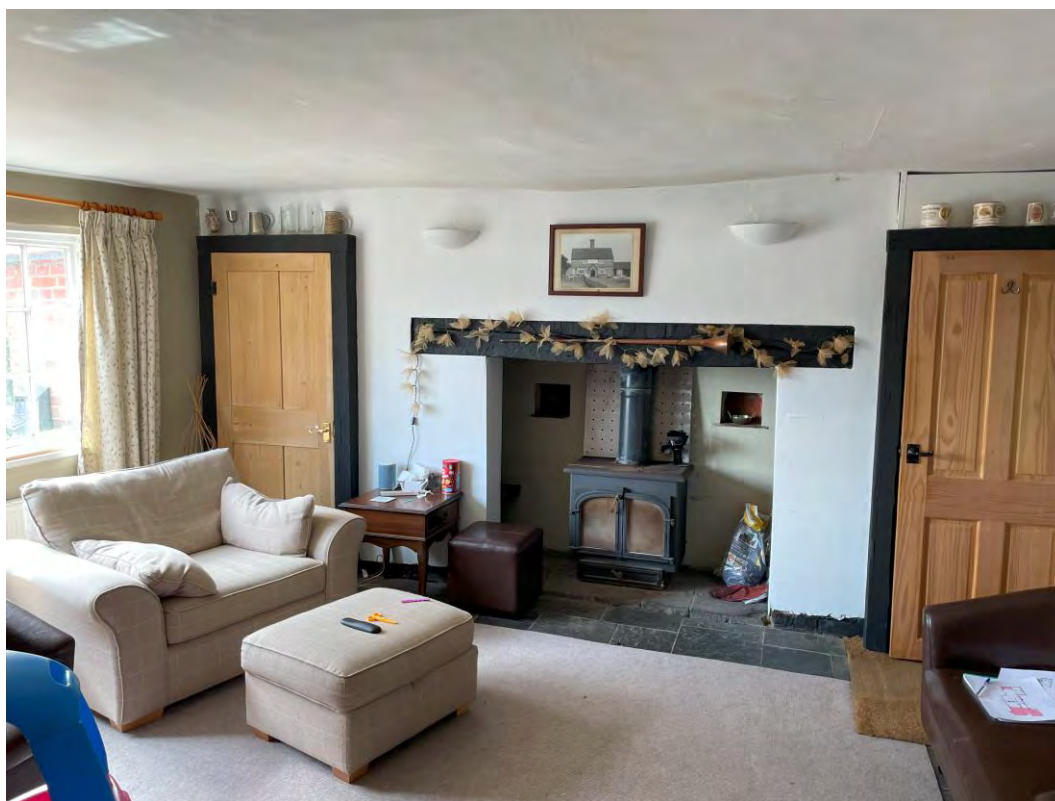
Figure 16: Room 2

- 3.18 Room 2 currently acts as a lounge area. It too has an inglenook fireplace with modern wood burner, and hearth. The shelves and benches also appear to have undergone a greater amount of alteration than in room 1. The floor is of modern granite with a timber skirting – dating from the early 19th century – runs along the bottom of the walls. The original external north wall has been knocked through to provide access to the north extensions. A timber frame is visible, but this is a modern construction and is not attached (it has been constructed from timber from several sources).
- 3.19 There is currently a hole in the rear wall that shows the fabric of this original element is red brick and lime mortar. As shown in plans from 2000 (00/05234/FUL; Appendix 4) this room was once the location of the bar.

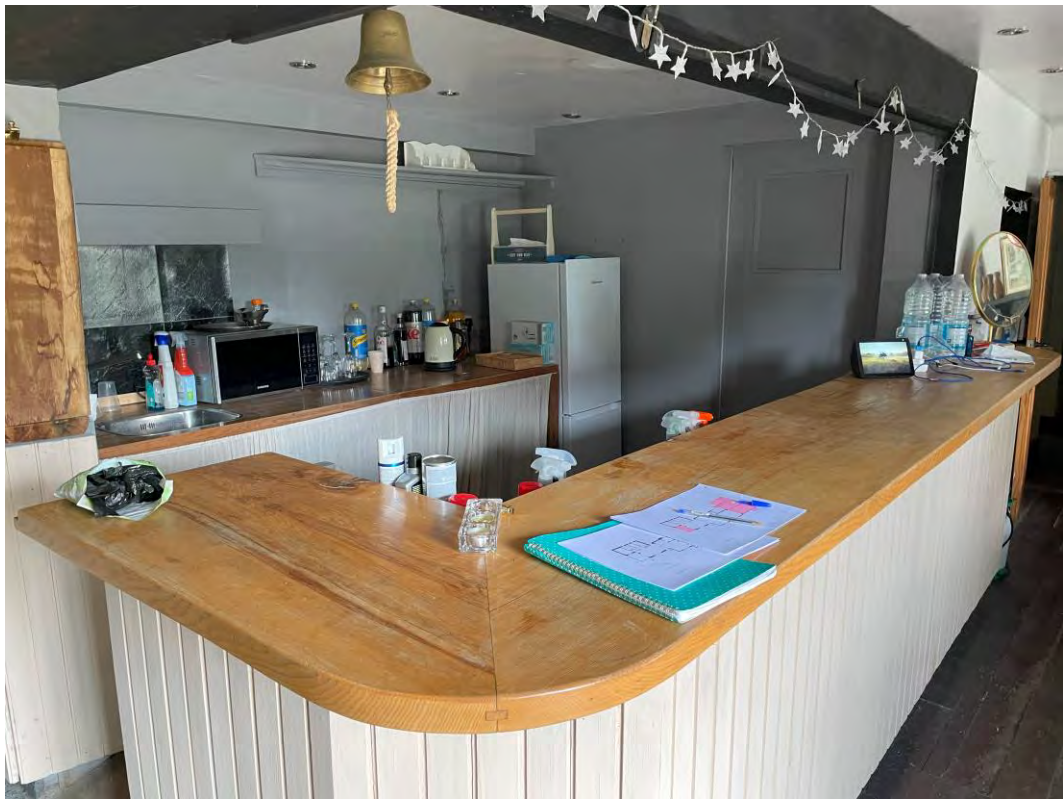
Figure 17: Room 3; bar area.

- 3.20 Rooms 3 and 4 were once a single room and were constructed in the 18th century. Room 3 (Figure 17) is now the location the bar and is connected to room 1 through the partial demolition of the original rear wall. The bar is a modern addition as the kitchen fittings. The floor is concrete with red tiles on top. The wall dividing rooms 3

and 4 is a modern stud wall (see floor plan for 00/05234/FUL; appendix 4). Room 4 is currently used as utility and storage room and has a modern concrete floor. Though a timber hatch to cellar survives.

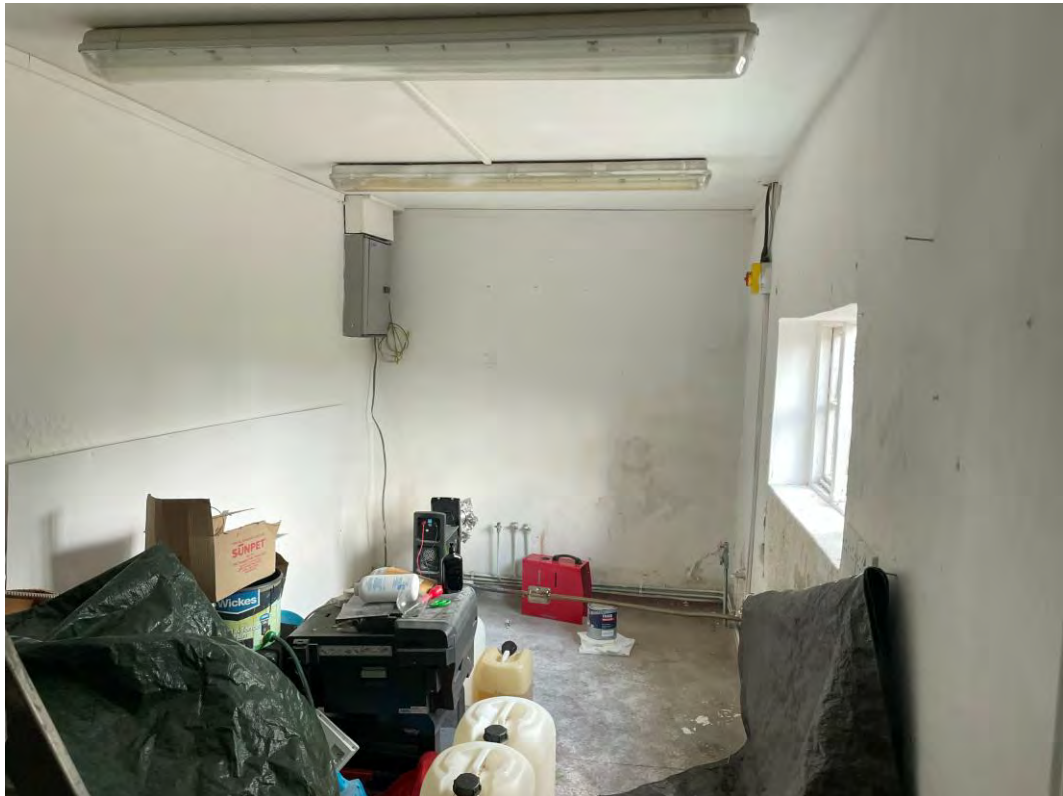
Figure 18: Room 5

3.21 Room 5 was a 18th century addition. Its north wall has been demolished and it is **now part of the pub's kitchen**. It has a concrete floor and an early-mid 20th century timber casement window.
