REBUTTAL STATEMENT

King William IV, Speen

Ref 25/05240/CLE

Save the King William IV Group

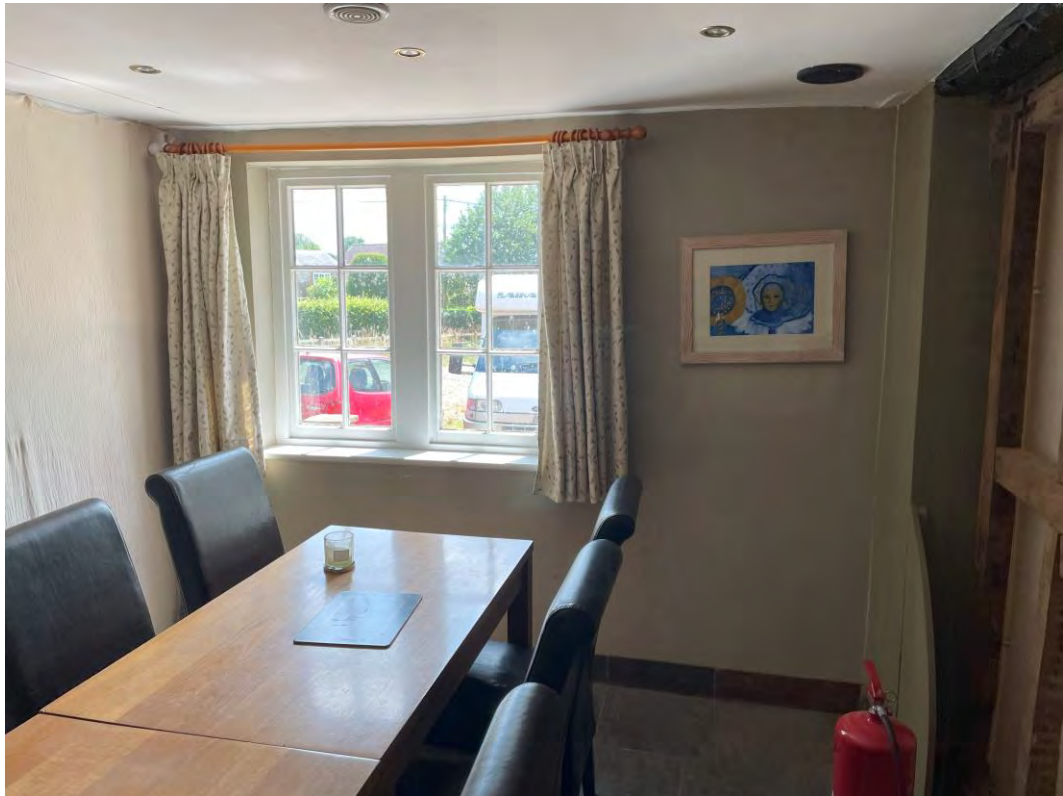
- 3.22 Rooms 10 and 11 are post 1960 additions. They are currently a kitchen and storage areas.
- 3.23 Room 9 was once a small barn or storage area, added in the 19th century. However, it has undergone significant alteration in the 20th century including the addition of a bay window. It has a concrete floor, and whilst the 12 light window is timber it is a modern replacement, likely inserted when the late 20th century bay window was added. A door opening in the south-west corner of the room has been blocked up. As discussed above, the timber frame is not attached.

Figure 19: Room 9. Currently divided by a sheet

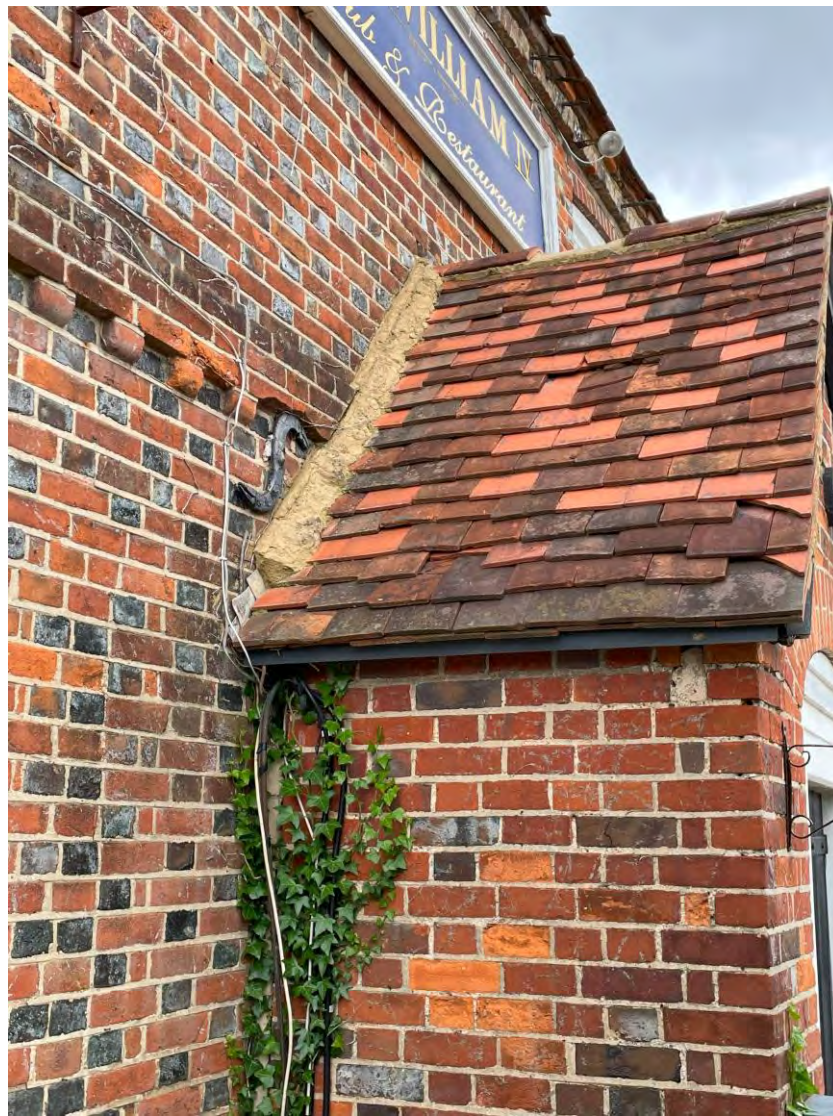
3.24 The porch (room 8) was added in the 19th century, as evidenced by the exterior brickwork. It has a red tile floor and timber skirting.

Figure 20: Porch brickwork is clearly different from that of the original building.

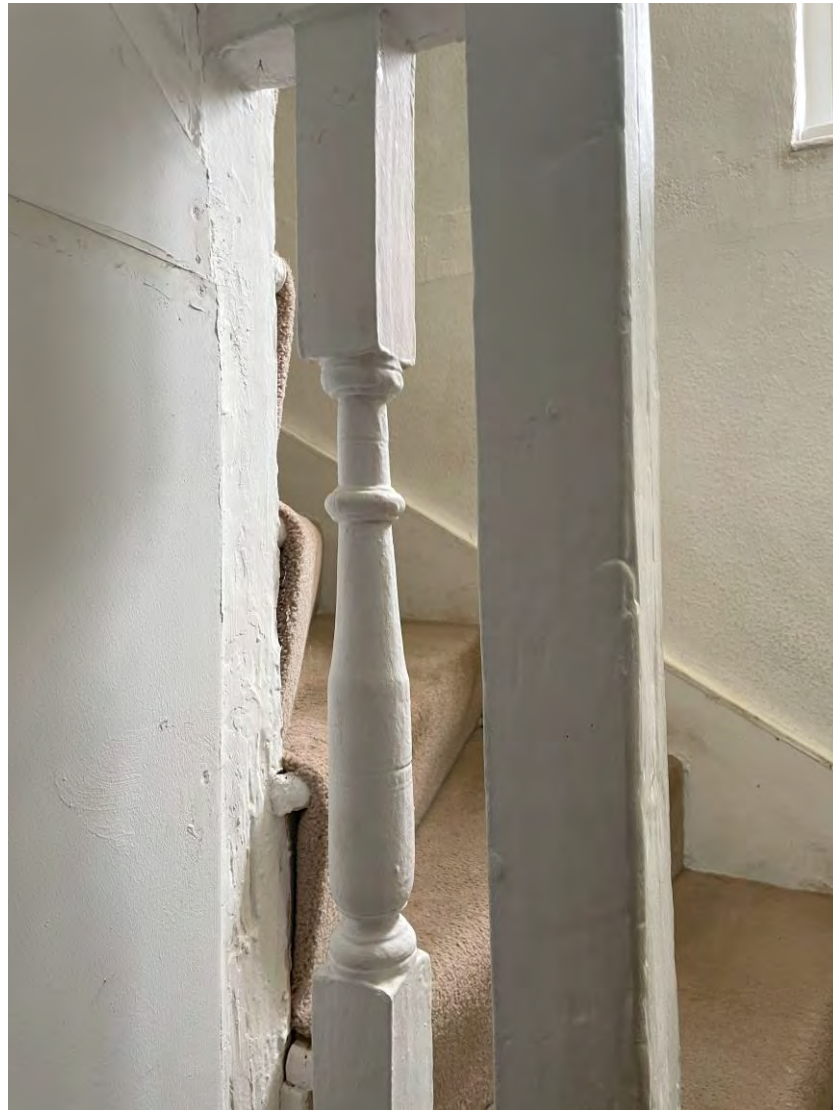
Figure 21: Staircase balustrade

- 3.25 Room 6 contains the staircase. It is clearly historic but accurately dating it is difficult. The finials and handrail suggest a mid-late 17th century date (finial is not dissimilar from the 1669 York type, whilst the handrail is similar to several late 17th century types). The balustrade is closest to an early 17th century Westmorland type.
- 3.26 Rooms 12-15 are all within the modern extension.
- 3.27 Doors at ground floor level are all modern replacements.

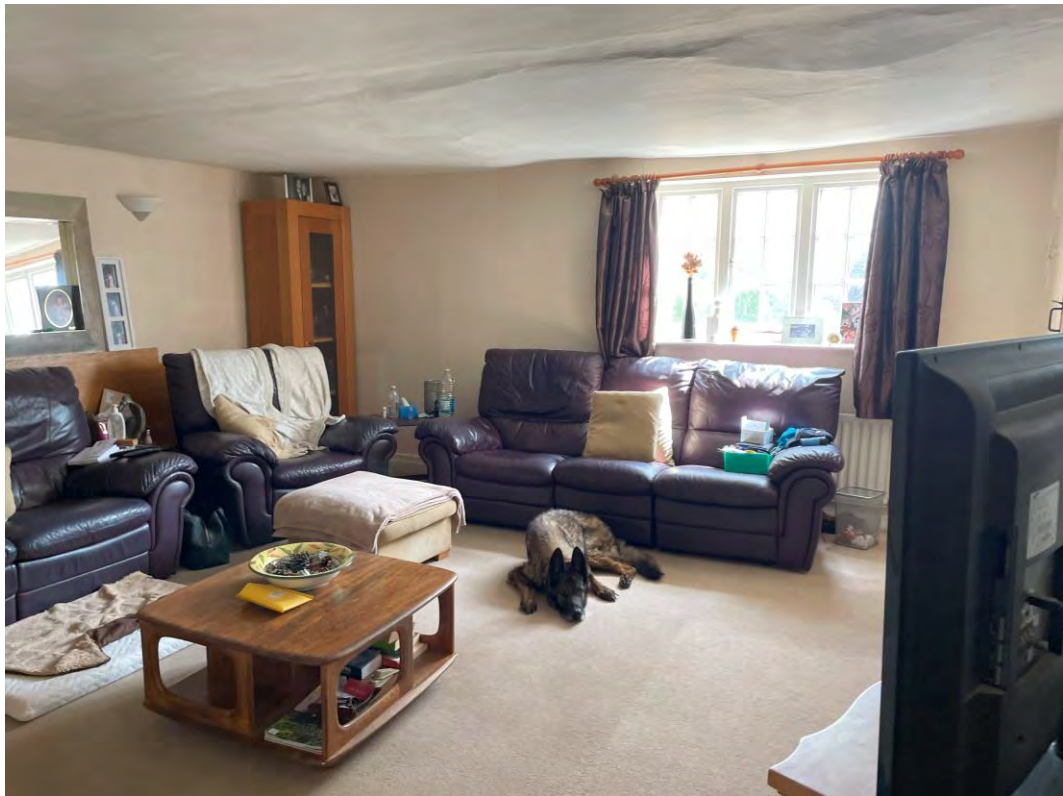
Figure 22: Room 16.

- 3.28** At first floor level, room 16 has its original dimensions. It has a small fireplace, with a modern wood burner. The surround and hearth are modern replacements but in keeping with the character of the house in having a simple design. The undulating surface of the ceiling suggests that it is lath and plaster, but the historic floor has been replaced with chipboard (as has the entirety of the first floor).
- 3.29** Rooms 17 and 18 (and the hallway room 25) were once a single room – part of the original house - now separated by a modern stud wall.

However, figure 22 on page 26 of the 2023 Heritage Impact Report by HCUK Ltd for the owner as part of the planning application for change of use (23/07884/FUL) shows the first floor sitting room still fully furnished and the German Shepherd lying on the floor over three years later, in November 2023.

The Planning Statement repeats false claims about the use of the ground floor seen in the Statutory Declarations. Paragraphs 4.3 and 4.4 repeat the claim that the *“former first floor living room was converted to a bedroom”*. However, the photograph figure 22 on page 26 of the Heritage Impact Report by HCUK Ltd, which was prepared for the original planning application for the owner in November 2023 shows the first floor sitting room still fully furnished three years later.

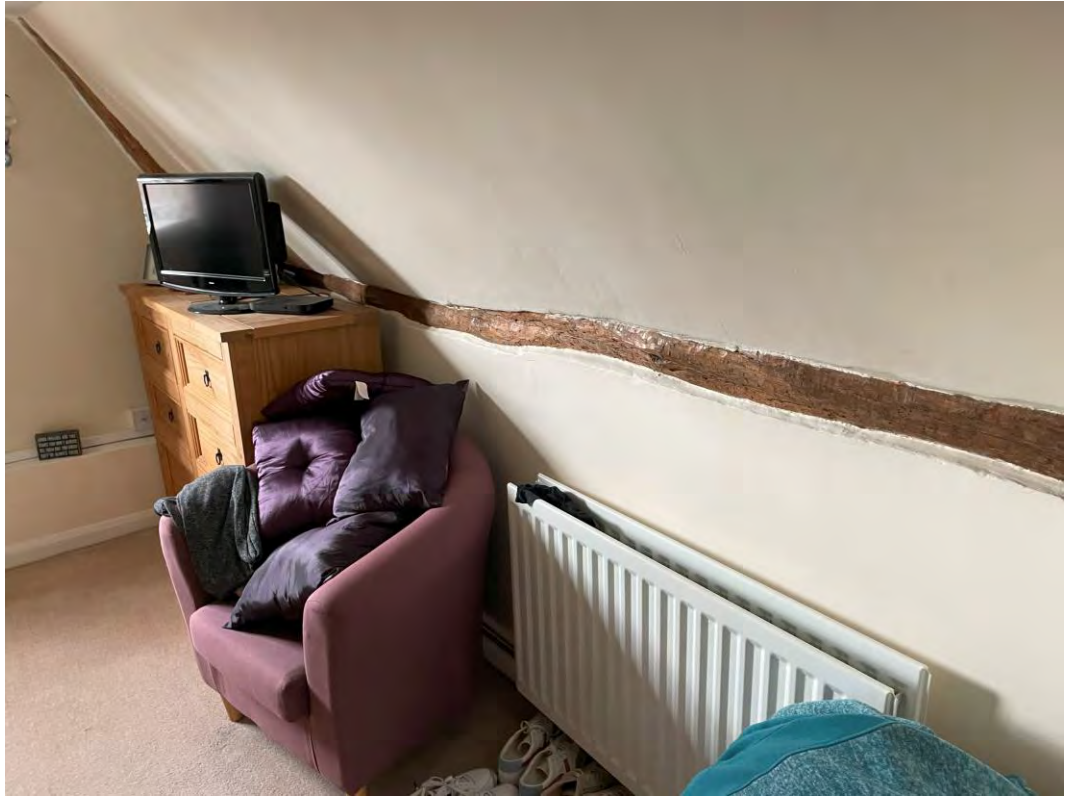
- 3.32 Historically the second floor was the attic. It has now been converted into bedrooms. Within these rooms (26-29) it is possible to see part of the timber roof. Both casement windows are timber, as are doors though these are modern additions.

Figure 23: Timber roof structure, visible on second floor.

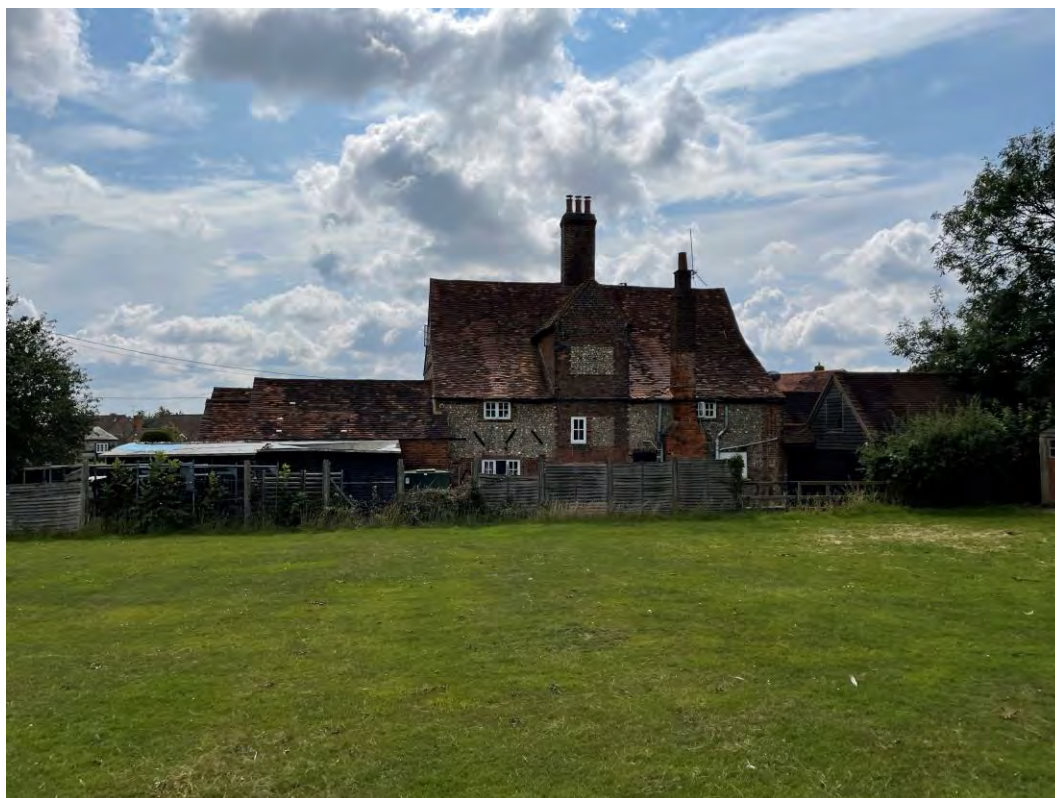
Figure 24: Rear elevation of the King William IV Public House. As seen from the playing fields.

- 4.10 The rear of the listed building can also be seen from the public realm (Figure 24), within the playing fields. This is an excellent position to see the historic development of the property, where materials such as the red brick and flint intermingle. However, the rear extension (to the north) is of a poor quality and is not in character with the historic building (it is constructed of timber with a sheet metal roof). It does distract from the appreciation of the listed building, though not in a significant way.

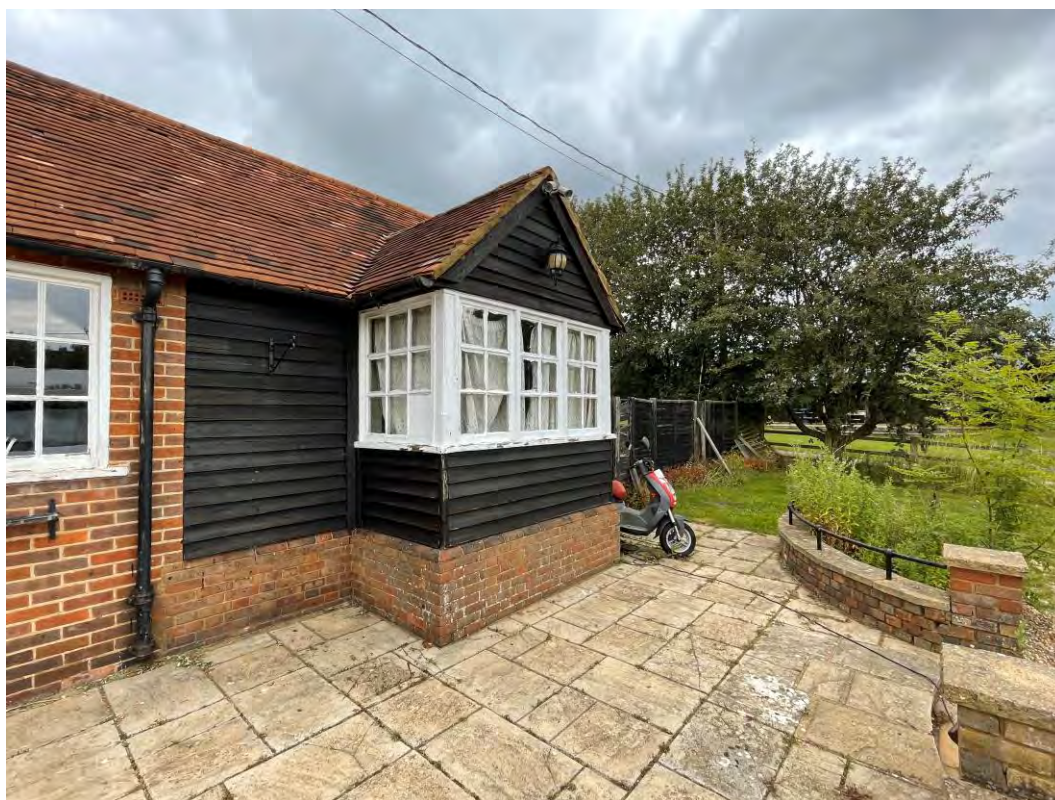
right,¹⁵ particularly following several alterations. No aspect of the significance of the listed building relies on the existence or presence of the north extensions, so their absence will make no difference in that respect. The demolition of the extensions will not erode the significance of the listed building, and it will not cause harm to significance within the context of paragraphs 201 or 202 of the NPPF.

Figure 29: Bay window of the north extension, added in the 1980s.

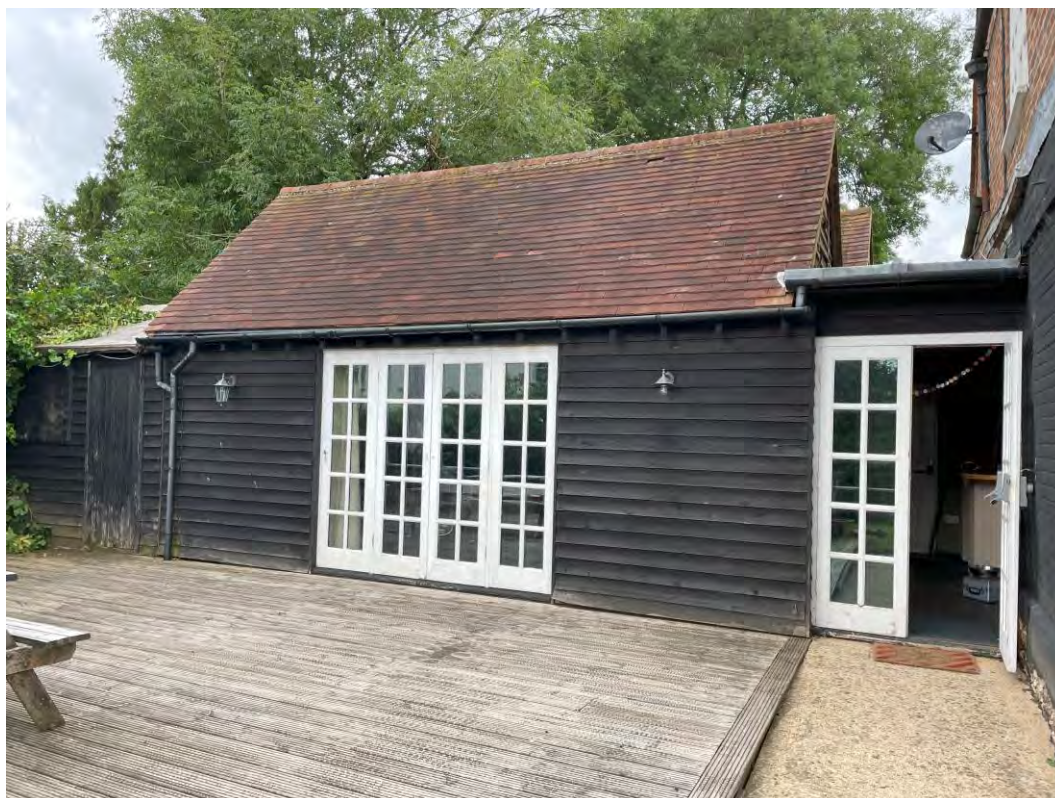
Figure 30: Modern south extension with ice cream parlour on the far left.

- 5.3 The ice cream parlour on the west side of the building is a modern structure and is therefore not of special architectural or historic interest. Its demolition will not cause harm to significance within the context of paragraphs 201 or 202 of the NPPF.

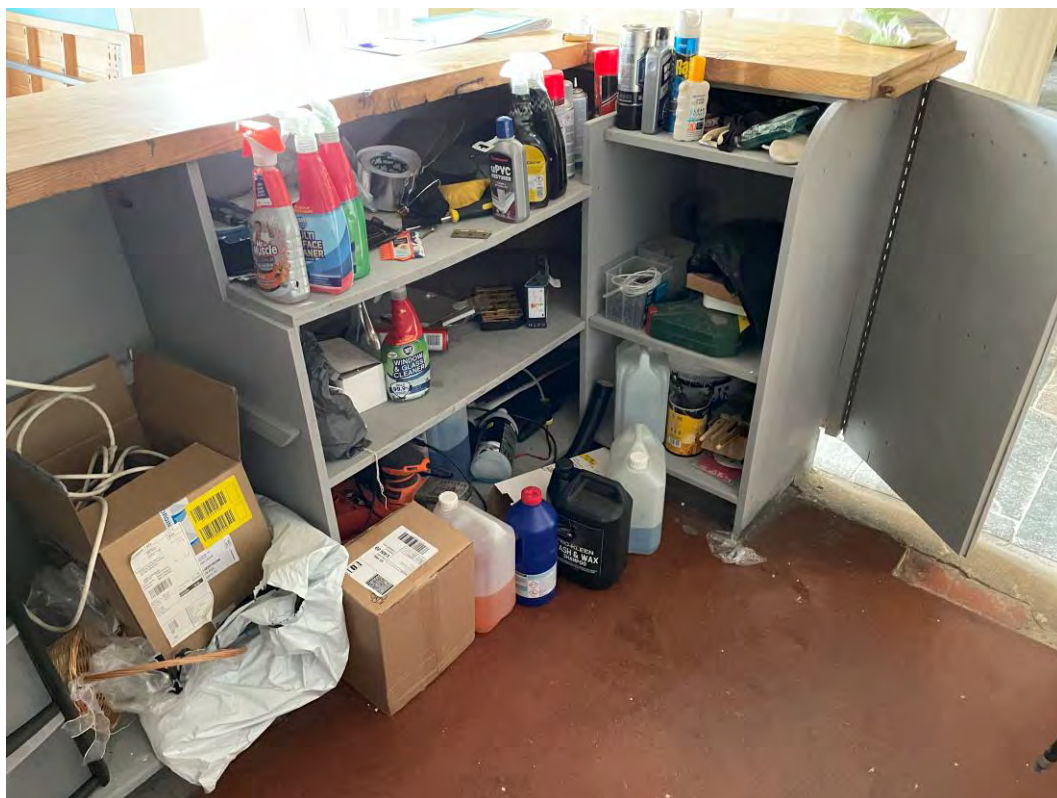
- 5.4 Aside from the north extensions and the ice cream parlour only modern stud walls will be removed. This includes a modern wall between the existing bar and storage room (see appendix 4; the wall is not shown on 2000 plans), which will somewhat restore the original plan form of this part of the house. This should be considered a minor heritage benefit.
- 5.5 It is proposed to remove the bar. This is a modern addition largely constructed of plywood (see historic plans in appendix 4), and its design is that of a modern bar rather than that of an historic bar. Aside from it being a bar it in no way represents or reflects the historic bar that would have once existed. Therefore, it is of no heritage significance and its removal will not cause harm to significance within the context of paragraphs 201 or 202 of the NPPF.

Figure 31: View behind the existing bar. Plywood construction is clear.

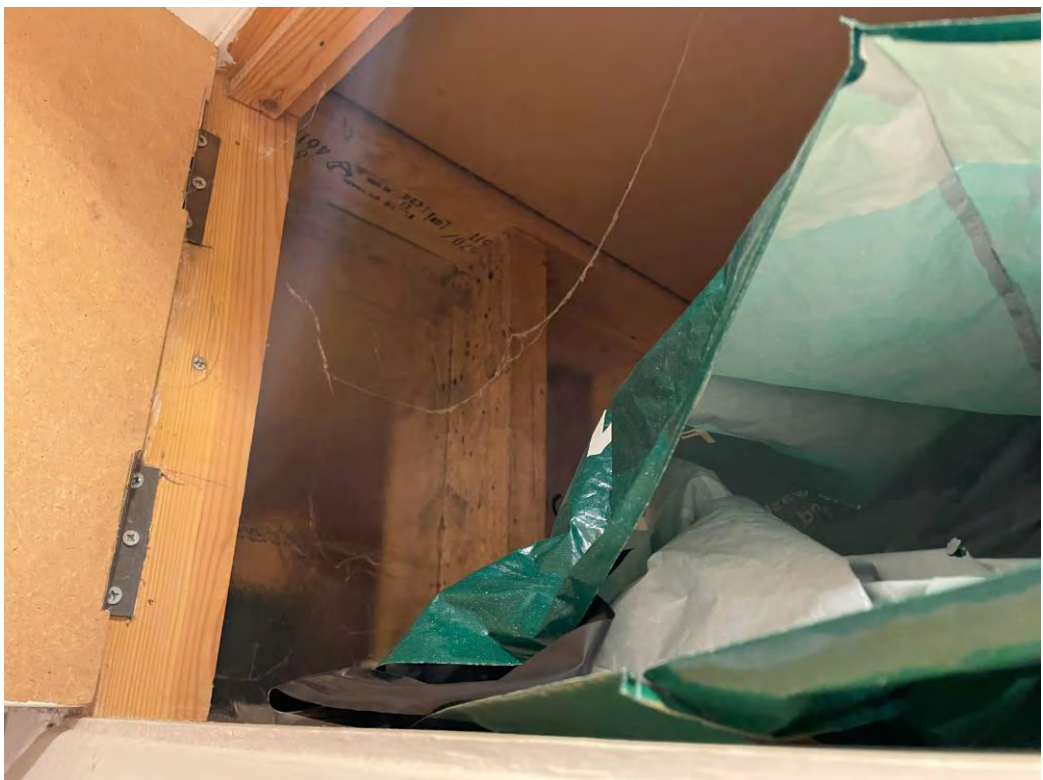
Figure 33: Modern wall to be removed, room 22.
